# **INDOOR AIR QUALITY ASSESSMENT**

**Columbus Park School  
75 Lovell Street  
Worcester MA**

Prepared by:  
Massachusetts Department of Public Health  
Bureau of Environmental Health  
Indoor Air Quality Program  
November 2019

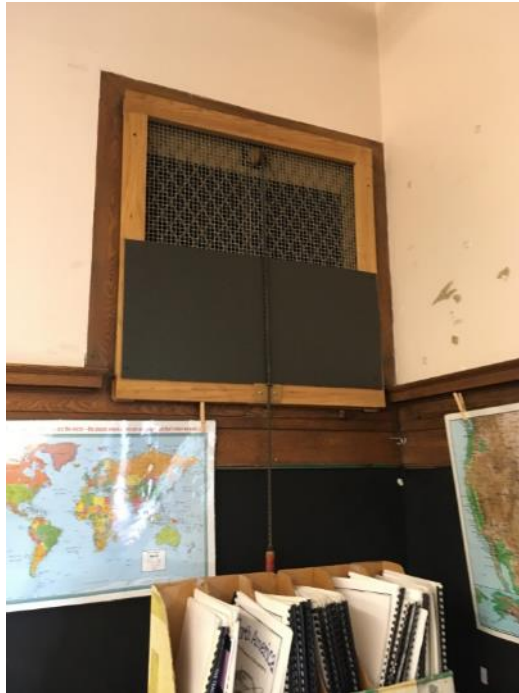
**Picture 1**

The building has two types of ventilation systems. The 1913 wing was originally equipped with a natural ventilation system that used the stack effect to circulate heat and air through classrooms. It appears that the original airshafts were converted into a mechanical ventilation system with an air handling unit (AHU) located in the basement. Classrooms in the 1913 wing have vents that now function as mechanical supply and return vents (Pictures 1 and 2). The basement has been subdivided into classrooms; added ductwork supplies fresh air through diffusers (Picture 3).

**Fresh air supply vent**

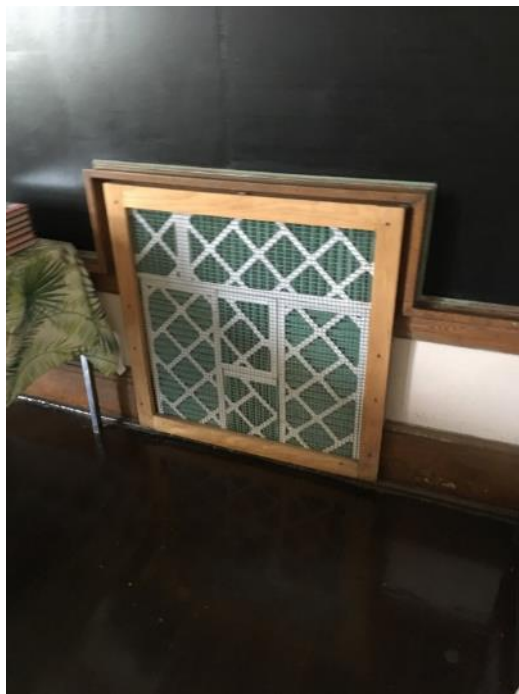
**Picture 2**

**Return air vent with filters attached**

8. After consulting with a ventilation engineer, examine the feasibility of changing filters in HVAC units at least twice a year with Minimum Efficiency Reporting Value (MERV) 8 (or higher) filters. Clean HVAC and univent cabinets of debris and dust when filters are changed.

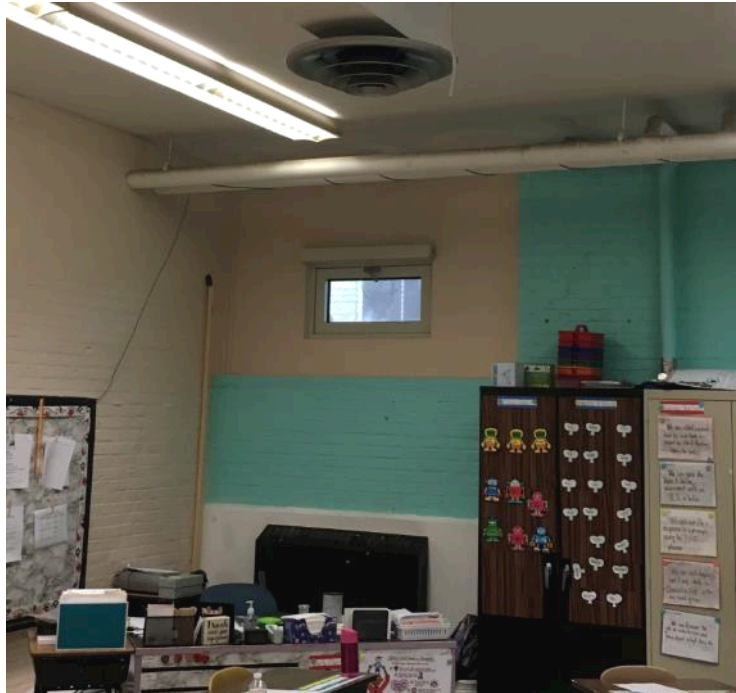
**Picture 3**

**Retrofitted basement fresh air supply and ductwork**

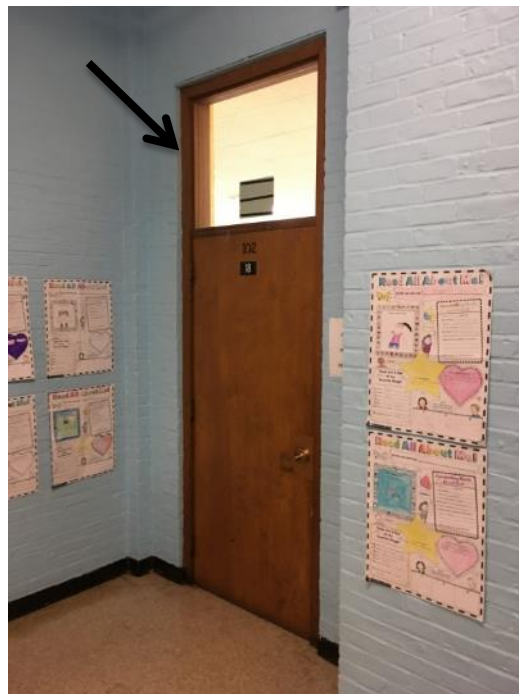
**Picture 4**

The 1913 portion of the building appears to be originally designed to provide fresh air by opening windows and using cross-ventilation. The building is equipped with windows on opposing exterior walls along with hinged windows (called transoms, Picture 4) located above the doors between classrooms and the hallways. The transom enables the classroom doors to be closed while maintaining a pathway for airflow. This design allows for airflow to enter an open window, pass through a classroom, pass through the open transom, enter the hallway, pass through the opposing open classroom transom, into the opposing classroom and exit the building

on the leeward side (opposite the windward side) ([Figure 1](#)). With all windows and transoms open, airflow can be maintained in a building regardless of the direction of the wind. The system fails if the windows or transoms are closed ([Figure 2](#)). All transoms in the building were sealed, which prevents cross-ventilation as originally designed. The 1950s building has no transoms.

**Transom**

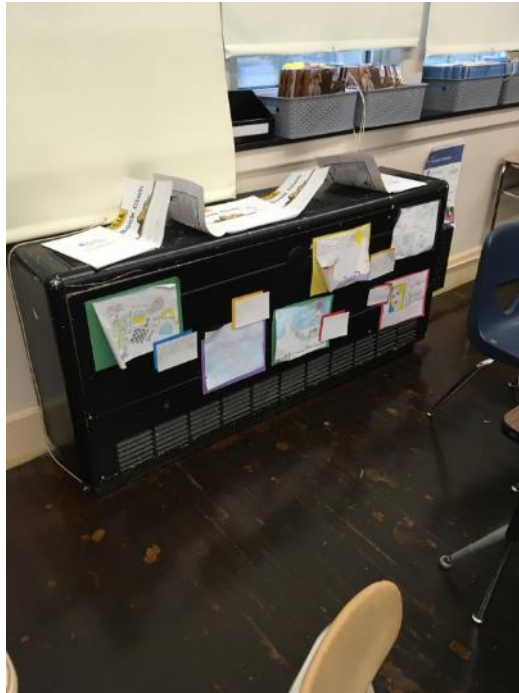
**Picture 5**

Fresh air for classrooms in the 1950s wing is supplied by a unit ventilator (univent) system (Picture 5). Univents draw air from outdoors through a fresh air intake located on the exterior walls of the building and return air through an intake located at the base of each unit. Fresh and return air are mixed, filtered, heated and provided to classrooms through an air diffuser located in the top of the unit ([Figure 3](#)).

With regard to HVAC system function, according to the American Society of Heating, Refrigeration and Air-Conditioning Engineers (ASHRAE), the service life for a unit heater, hot water or steam is 20 years, assuming routine maintenance of the equipment (ASHRAE, 1991). Despite attempts to maintain the univents (e.g., oiling bearings, changing filters regularly), the operational lifespan of this equipment has been exceeded in all areas of the CPS. Maintaining the balance of fresh to exhaust air will become more difficult as the equipment ages and as replacement parts become increasingly difficult to obtain.

**Unit ventilator (univent)**

1. Consideration should be given to replace HVAC units/components as they become past their service life. If not conducted already, consider contacting an HVAC engineering firm for an assessment of the ventilation system’s components and control systems (e.g., controls, air intake louvers, thermostats). Based on the age, physical deterioration, and availability of parts for ventilation components, such an evaluation is necessary to determine the operability and feasibility of repairing/replacing the equipment.

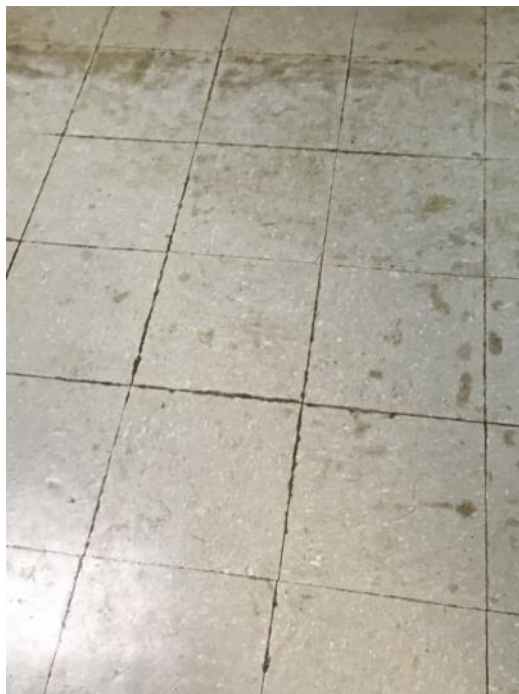
**Picture 6**

As mentioned previously, the lowest floor of the building was converted into classrooms sometime in the 1950s-1960s. The basement has several flooring materials, including terrazzo and tile. Due to the condition of hallway floor tiles (Picture 6), it appears that the basement floor becomes wet with condensation during hot, humid weather, despite the use of dehumidifiers in basement classrooms. This phenomenon was likely exacerbated during the weather conditions experienced in New England during the summer of 2018:

Since the building was originally constructed in 1913, it is highly unlikely that the floor has either insulation or a vapor barrier. In this condition, the floor likely has a temperature similar the material beneath the floor (e.g, soil, sand, rock ledge, rock fill). If the temperature of the floor is below or equal to the dew point, the floor will begin to accumulate condensation<sup>1</sup>.

**Water-damaged floor tiles in basement**

5. Ensure all former locker room drains are permanently sealed.
6. Operate dehumidifiers during hot, humid weather to reduce relative humidity in basement areas. Ensure all dehumidifiers are emptied, cleaned and maintained regularly to prevent spills and odors.

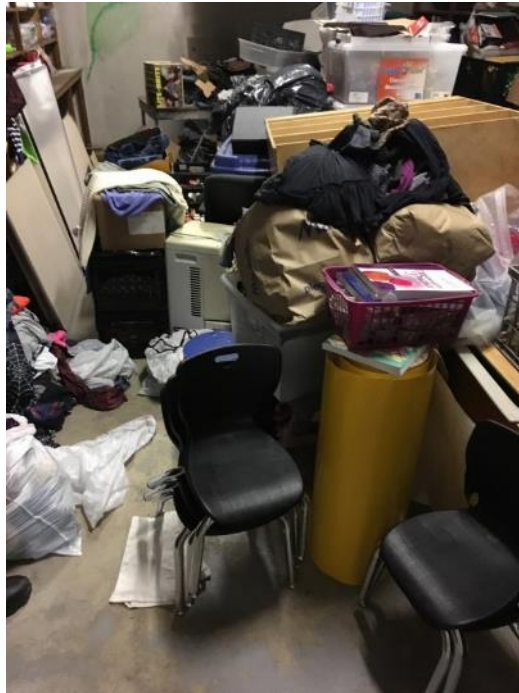
**Picture 7**

The basement level of the building contains a significant amount of materials that can support mold growth if exposed to moisture (Pictures 7 and 8). In addition, a number of conditions exist that may increase relative humidity/moisture conditions in the basement:

- Porous materials were present in the basement area. It is highly recommended that materials that can support mold growth be removed. Porous materials such as paper, cardboard, cloth and leather can all become mold colonized if repeatedly exposed to moisture.

**Stored materials in basement**

4. Remove all porous materials from the basement floor including carpeting and stored materials. Reduce the amount of materials stored in the basement area in general, and store remaining materials in waterproof totes.

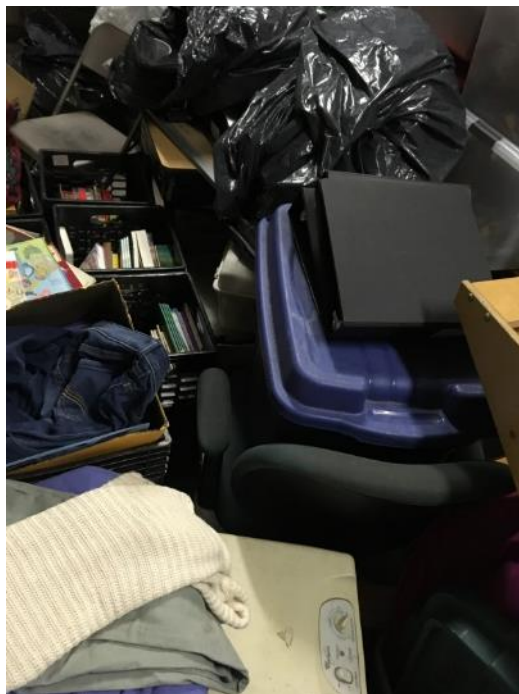
**Picture 8**

**Stored materials in basement**

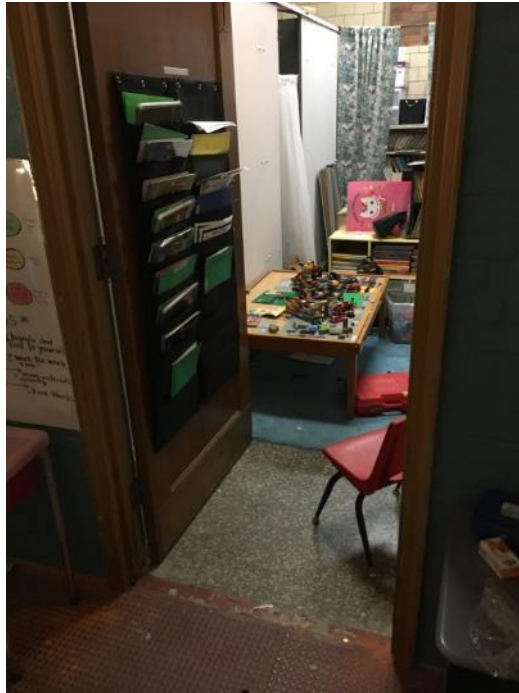
**Picture 9**

- The basement used to contain locker rooms including a shower (Picture 9). It could not be determined if the shower floor drains were permanently sealed. Drains are usually equipped with curved pipe in an “s” shape to form a device called a trap. Drain traps are normally filled with water to create a seal between the building's sanitary sewer line and the system designed to ventilate sewer gas. Without the water seal in a drain trap, water vapor and sewer gas can be drawn into an area. Sewer water can contain a number of bioaerosols (including fungi such as mold) that can be drawn into an area with a dry drain trap, particularly when a sewer system has a large influx of water during heavy rainstorms. The water inside the trap requires replenishment on a regular basis (every other day, particularly during the heating season) to maintain airtightness of the trap.

**Former locker room shower area**
